Captured Images

Generated Viewpoints

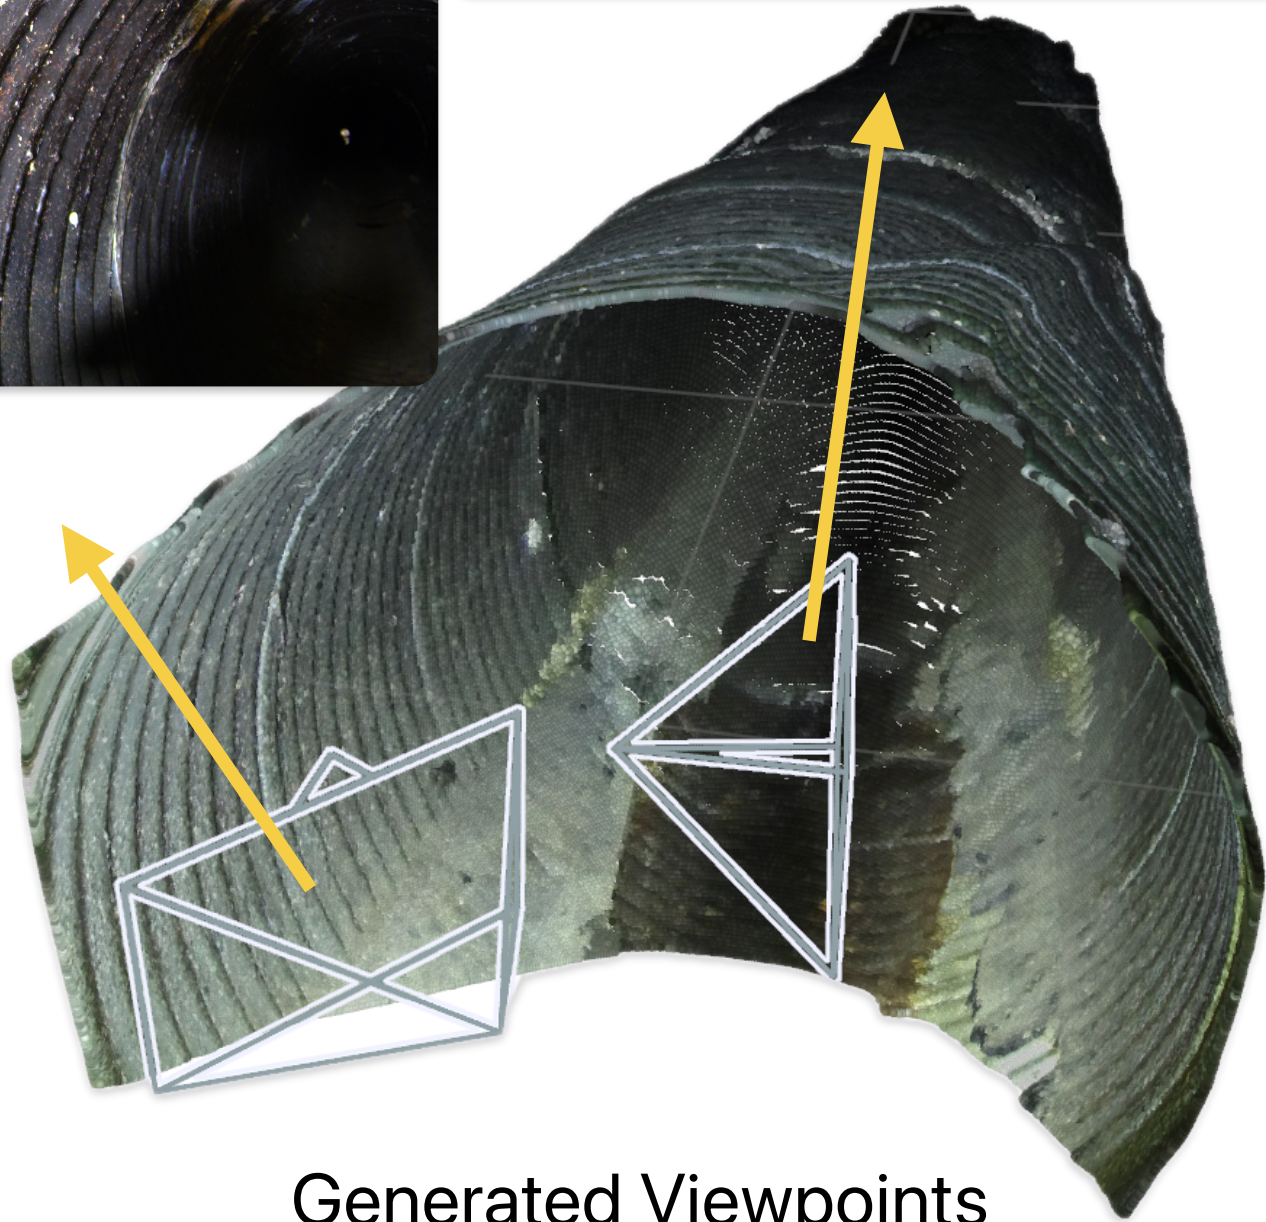
Concentrated cracks and rough joints along the left wall indicating potential spalling or joint distress requiring closer inspection.(0.35)

Center inner ring surface shows potential micro-cracking or spalling near the culvert throat requiring closer imaging. (0.20)

White mineral deposits and efflorescence along the right-hand wall indicate moisture ingress and possible deterioration at the joints (0.20)

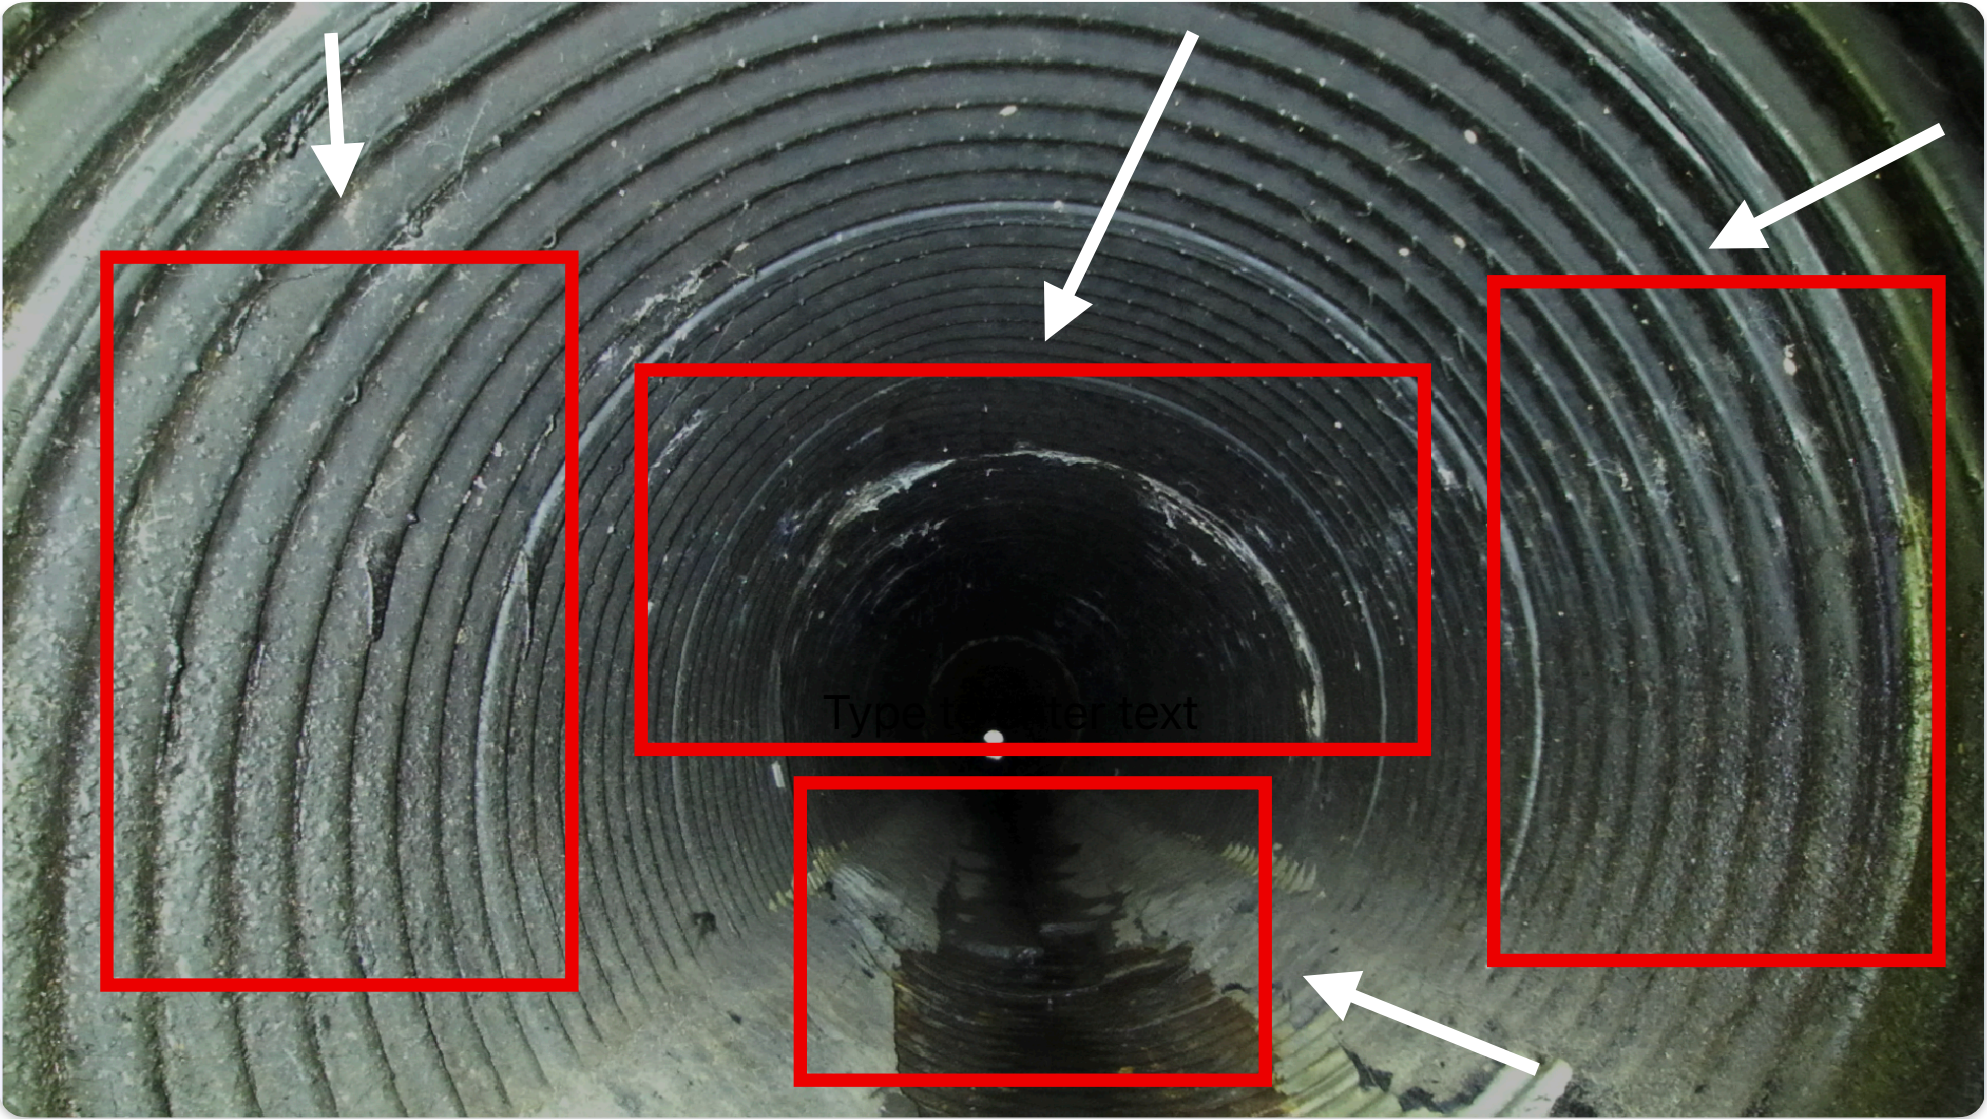
Dark wet staining and pooling at the bottom suggest seepage or leakage through the culvert wall or joints. (0.25)
