Captured Images

Generated Viewpoints

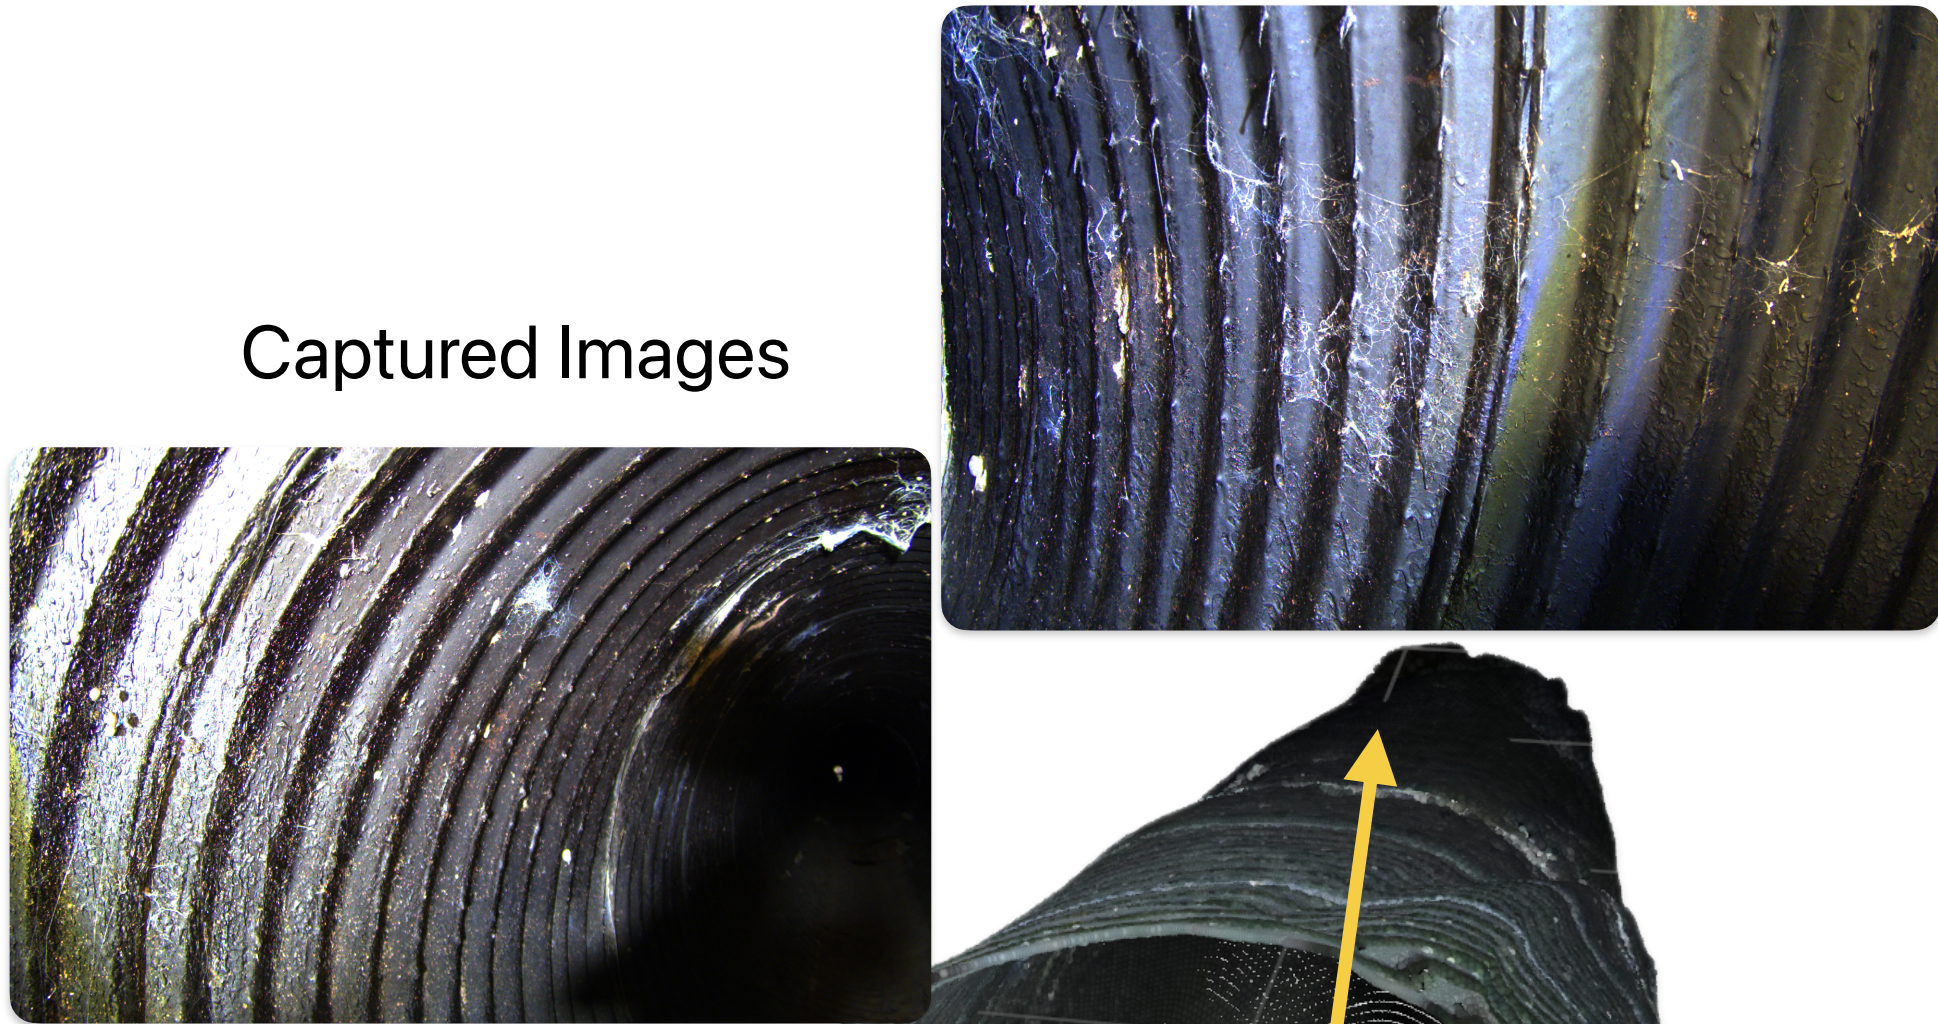
Concentrated cracks and rough joints along the left wall indicating potential spalling or joint distress requiring closer inspection.(0.35)

Center inner ring surface shows potential micro-cracking or spalling near the culvert throat requiring closer imaging. (0.20)

White mineral deposits and efflorescence along the right-hand wall indicate moisture ingress and possible deterioration at the joints (0.20)

Dark wet staining and pooling at the bottom suggest seepage or leakage through the culvert wall or joints. (0.25)
